UV Fluorescence Imaging Guide

By Dr. Ellen Gualtieri, FORMULATRIX

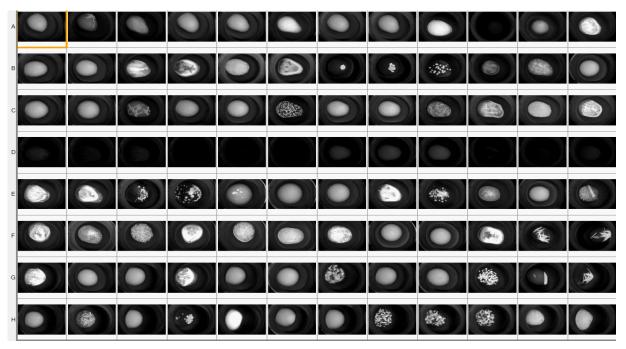
Figure 2 depicts UV fluorescent images of glucose isomerase screened against SaltRX screen. Row D shows significantly reduced fluorescence due to quenching from nitrates caused by ammonium and sodium nitrate present in that particular row of the screen, even though protein crystals are present in those drops.

Figure 2. Glucose Isomerase Sample and SaltRX Screen Imaged with UV. Row D Contains Ammonium Nitrate and Sodium Nitrate that Quenches UV Fluorescence, Resulting in False Negatives

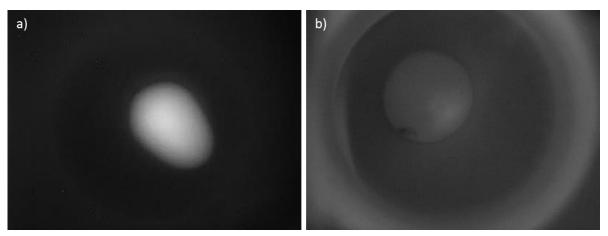
Figure 3a depicts a drop imaged on a SWISSCI MRC2 crystallization plate that has minimal fluorescence. The crystallization drop is easily imaged in UV and not obscured by background fluorescence. Image 3b depicts a drop imaged on a highly fluorescent plate, obscuring contrast in the protein drop.

Figure 3. Drops Imaged on Crystallization Plates with Varying Fluorescence Properties

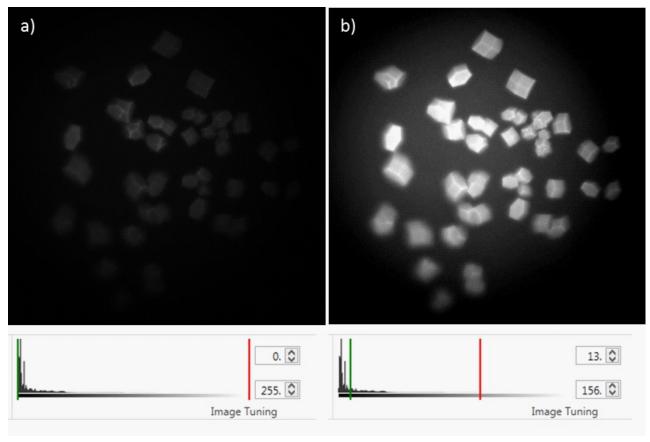
The series of images depicted in Figure 5 shows the same drop before and after the brightness and contrast was adjusted using the Image Tuning tool in ROCK MAKER. Image 5a is dark, and shows little drop content detail when compared to image 5b, which has been leveled appropriately in ROCK MAKER and shows more of the drop's contents.

Figure 5. Protein Samples Imaged with UV Before and After Leveling has been Applied
