UV Fluorescence Imaging Guide

By Dr. Ellen Gualtieri, FORMULATRIX

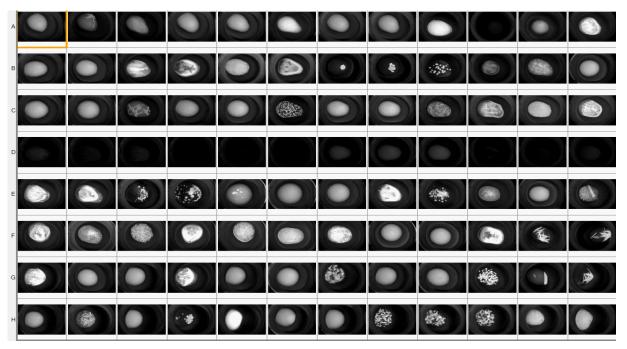
Figure 2 depicts UV fluorescent images of glucose isomerase screened against SaltRX screen. Row D shows significantly reduced fluorescence due to quenching from nitrates caused by ammonium and sodium nitrate present in that particular row of the screen, even though protein crystals are present in those drops.

Figure 2. Glucose Isomerase Sample and SaltRX Screen Imaged with UV. Row D Contains Ammonium Nitrate and Sodium Nitrate that Quenches UV Fluorescence, Resulting in False Negatives

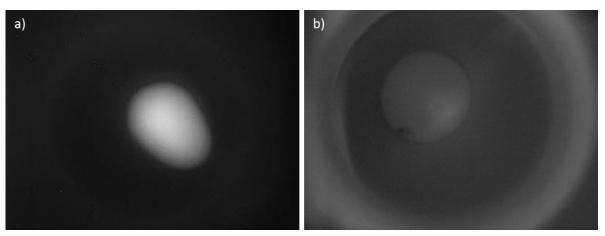
Figure 3a depicts a drop imaged on a SWISSCI MRC2 crystallization plate that has minimal fluorescence. The crystallization drop is easily imaged in UV and not obscured by background fluorescence. Image 3b depicts a drop imaged on a highly fluorescent plate, obscuring contrast in the protein drop.

Figure 3. Drops Imaged on Crystallization Plates with Varying Fluorescence Properties

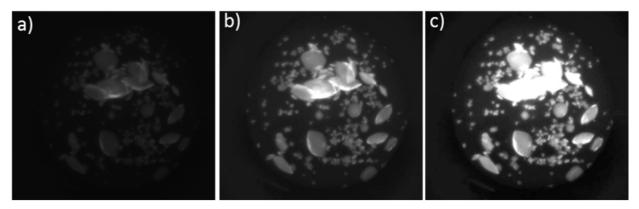
In the following series of images, the same drop was imaged with various exposure times. Image 4a is underexposed at an exposure time of 50 ms, and detail is lost in the image. Image 4b is correctly exposed at an exposure time of 200 ms, resulting in ideal drop content detail. Image 4c is overexposed at an exposure time of 500 ms, causing a loss of detail in particular areas when compared to image 4b.

Figure 4. Protein Crystals Imaged with UV at Different Exposure Times

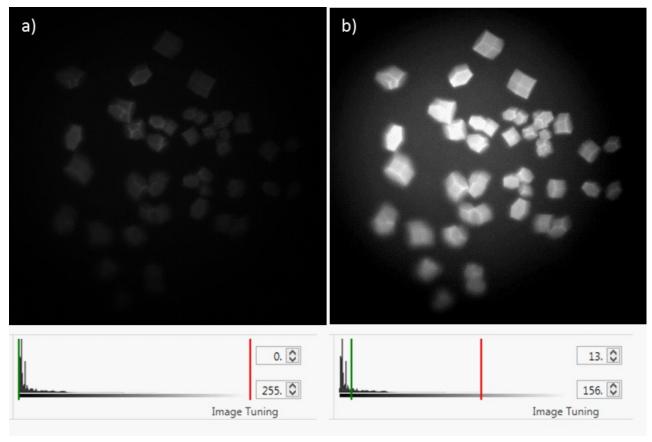
The series of images depicted in Figure 5 shows the same drop before and after the brightness and contrast was adjusted using the Image Tuning tool in ROCK MAKER. Image 5a is dark, and shows little drop content detail when compared to image 5b, which has been leveled appropriately in ROCK MAKER and shows more of the drop's contents.

Figure 5. Protein Samples Imaged with UV Before and After Leveling has been Applied

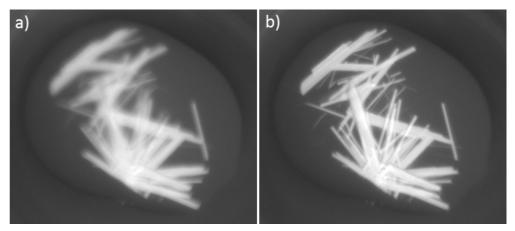
In Figure 6 below, image 6a depicts a poorly focused extended focus image (EFI), resulting in loss of detail. This was caused by the start and stop z range being below the focal plane of the crystals in the drop. By adjusting the z range to start at the bottom of the drop and then finish at the top, an appropriately focused image was obtained as shown in image 6b.

Figure 6. Protein Crystals Imaged with UV at Varying Focus
